UNDERWATER BRIDGE INSPECTION REPORT

STRUCTURE NO. 2366

MISSISSIPPI RIVER

DISTRICT 2 - BELTRAMI COUNTY, CITY OF BEMIDJI

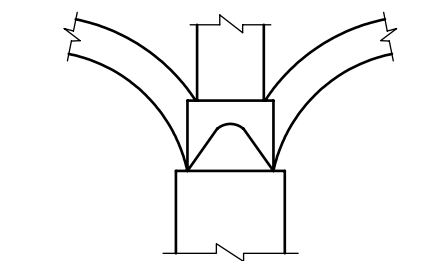
TYPICAL END VIEW OF PIERS

- 4 Band of scaling, spalling, and section loss around both piers typically located between 2 feet below and 2.5 feet above the waterline, with typical penetrations of 3 to 4 inches and maximum penetrations of 6 to 9 inches. The heaviest deterioration was located around the upstream pier noses and the middle sections of the east side of Pier 1 and the west side of Pier 2.

Monitor the extent of the section loss during future inspections, and if found to be significantly progressing, repairs may be warranted to ensure long term serviceability at that time.
